**Flood Control Project Maintenance
Levee Inspections****LMA District Cover Sheet****Spring 2015 Levee Inspection Results****Sacramento Maintenance Yard Willow Slough Bypass**

Levee Inspection Report By Mile - Spring 2015

Sacramento Maintenance Yard Willow Slough Bypass

Waterway	Bank	Unit Miles	Inspection Start/End	Inspector
Unit No. 01 Willow Slough Bypass or North Levee	Left	5.05	04/16/2015 04/16/2015	Jai Lor

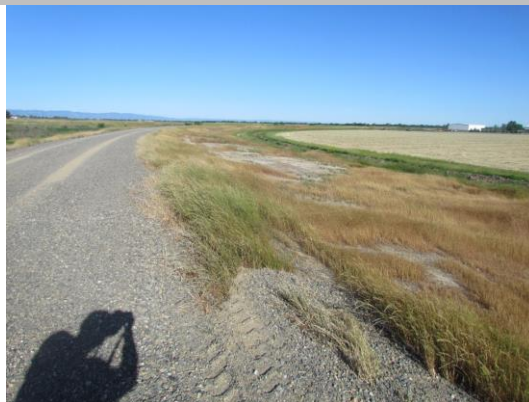
Photo 1 of 1 : SP_2015_ST0012_295_3_20150421_00002.jpg

LM Start	2.95	Rating **	A	Issue No.	3
LM End	5.03	Issue Type +	Ma	Location *	LS
Category	Earthen Levee			GPS Latitude/Longitude	
				Start	End
Item	Vegetation			38.590584 °	38.600057 °
				-121.719707 °	-121.752780 °
DWR ID	DWR_ST0012_01_s _ 2015_3				
Action/Comments					
Control annual grass and weeds on the levee slopes and easements.

View of the vegetation on the landward side of the levee looking upstream. Spring 2015.

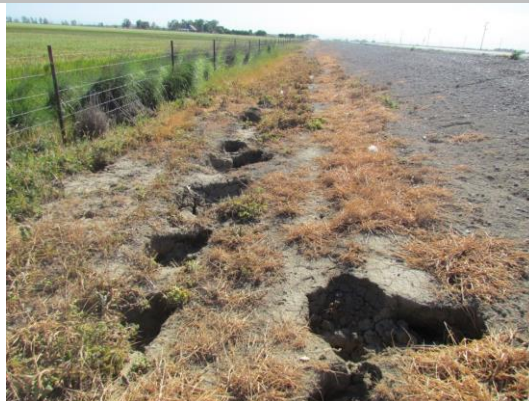
Photo 1 of 1 : SP_2015_ST0012_295_10_20150421_00004.jpg

LM Start	2.96	Rating **	M	Issue No.	10
LM End	2.96	Issue Type +	Ma	Location *	LS
Category	Earthen Levee			GPS Latitude/Longitude	
				Start	End
Item	Erosion / Bank Caving			38.590563 °	38.590563 °
				-121.720003 °	-121.720003 °
DWR ID	DWR_ST0012_01_s _ 2015_10				
Action/Comments					
Schedule repair of erosion site prior to the next inspection.

View of the erosion on the landward side of the levee looking downstream. Spring 2015.

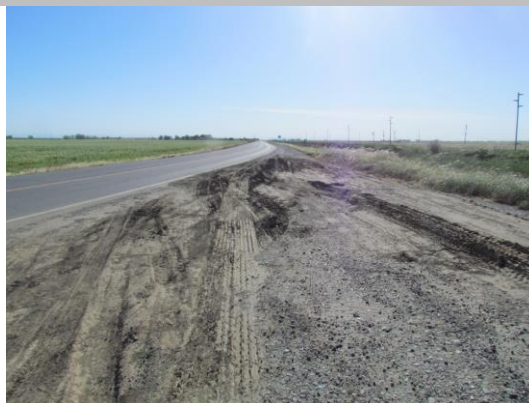
Photo 1 of 1 : SP_2015_ST0012_295_9_20150421_00003.jpg

LM Start	3.37	Rating **	M	Issue No.	9
LM End	3.37	Issue Type +	Ma	Location *	CR
Category	Earthen Levee			GPS Latitude/Longitude	
				Start	End
Item	Crown Surface / Depressions / Rutting			38.590650 °	38.590650 °
				-121.727581 °	-121.727581 °
DWR ID	DWR_ST0012_01_s _ 2015_9				
Action/Comments					
Add appropriate material and re-grade the levee to bring the crown above the design elevation.

View of the depression on the crown of the levee looking downstream. Spring 2015.

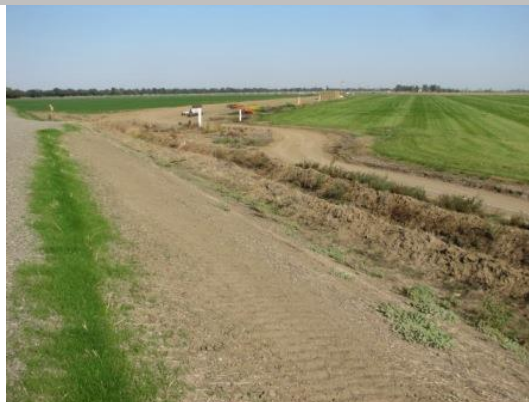
Photo 1 of 1 : SP_2015_ST0012_295_4_20150401_00001.jpg

LM Start	4.30	Rating **	M	Issue No.	4
LM End	4.61	Issue Type +	En	Location *	LS
Category	Earthen Levee			GPS Latitude/Longitude	
				Start	End
Item	Encroachments			38.598876 °	38.599845 °
				-121.739640 °	-121.745007 °
DWR ID	DWR_ST0012_01_s _ 2012_4				
Action/Comments					
Ditch

The agricultural ditch runs along the toe of the levee. Fall 2011

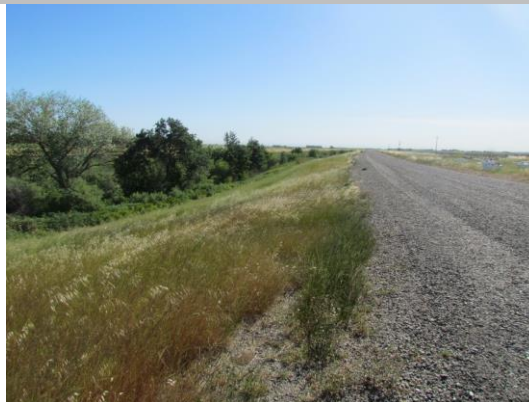
Photo 1 of 1 : SP_2015_ST0012_296_4_20150421_00008.jpg

LM Start	0.04	Rating **	M	Issue No.	4
LM End	7.45	Issue Type +	Ma	Location *	LS
Category	Earthen Levee			GPS Latitude/Longitude	
				Start	End
Item	Vegetation			38.599078 °	38.574468 °
				-121.753795 °	-121.638767 °
DWR ID	DWR_ST0012_02_s_2015_4				
Action/Comments					
Control annual grass and weeds on the levee slopes and easements.

View of the vegetation on the landward side of the levee looking downstream. Spring 2015.

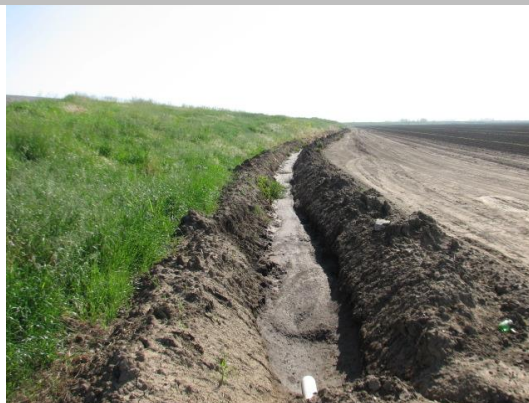
Photo 1 of 1 : SP_2015_ST0012_296_7_20150401_00002.jpg

LM Start	0.29	Rating **	M	Issue No.	7
LM End	0.55	Issue Type +	En	Location *	LS
Category	Earthen Levee			GPS Latitude/Longitude	
				Start	End
Item	Encroachments			38.598993 °	38.599047 °
				-121.749130 °	-121.744366 °
DWR ID	DWR_ST0012_02_s_2014_7				
Action/Comments					
Ditch

Agricultural ditch run along landside toe. Spring 2014

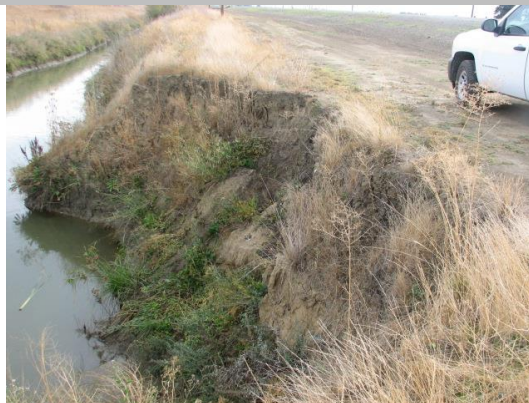
Photo 1 of 1 : SP_2015_ST0012_296_8_20150401_00003.jpg

LM Start	1.77	Rating **	M	Issue No.	8
LM End	1.77	Issue Type +	Ma	Location *	WS
Category	Earthen Levee			GPS Latitude/Longitude	
				Start	End
Item	Erosion / Bank Caving			38.589966 °	38.589966 °
				-121.727072 °	-121.727072 °
DWR ID	DWR_ST0012_02_s_2012_8				
Action/Comments					
Note and monitor erosion site.

Erosion on the edge of the channel. Fall 2012

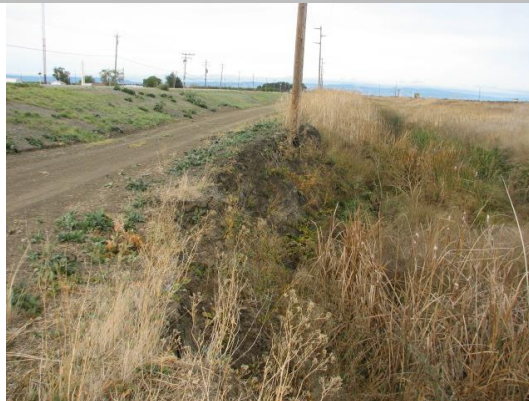
Photo 1 of 2 : SP_2015_ST0012_296_5_20150401_00001.jpg

LM Start	2.04	Rating **	M	Issue No.	5
LM End	2.04	Issue Type +	Ma	Location *	WS
Category	Earthen Levee			GPS Latitude/Longitude	
				Start	End
Item	Erosion / Bank Caving			38.589906 °	38.589906 °
				-121.722218 °	-121.722218 °
DWR ID	DWR_ST0012_02_s _ 2012_5				
Action/Comments					
Note and monitor erosion site.

Erosion on the edge of the channel. Fall 2012.

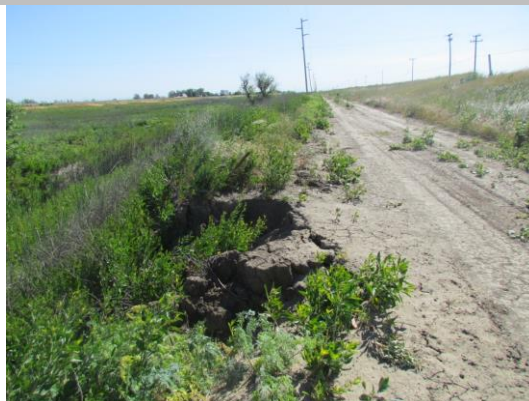
Photo 2 of 2 : SP_2015_ST0012_296_5_20150421_00009.jpg

LM Start	2.04	Rating **	M	Issue No.	5 (cont)
LM End	2.04	Issue Type +	Ma	Location *	WS

View of the erosion on the edge of the channel on the water ward side of the levee looking downstream. Spring 2015.

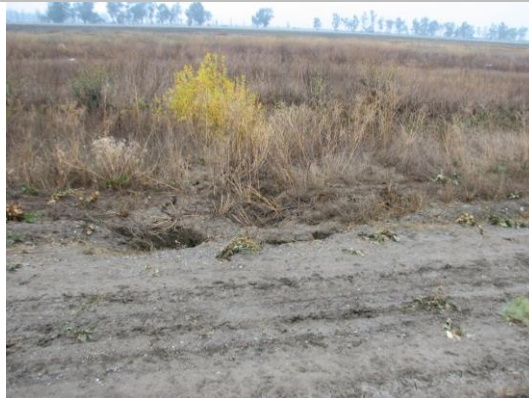
Photo 1 of 1 : SP_2015_ST0012_296_10_20150401_00005.jpg

LM Start	2.82	Rating **	M	Issue No.	10
LM End	2.82	Issue Type +	Ma	Location *	WS
Category	Earthen Levee			GPS Latitude/Longitude	
				Start	End
Item	Erosion / Bank Caving			38.589691 °	38.589691 °
				-121.707740 °	-121.707740 °
DWR ID	DWR_ST0012_02_f _ 2014_10				
Action/Comments					
Note and monitor erosion site.

Erosion on toe road. Fall 2014.

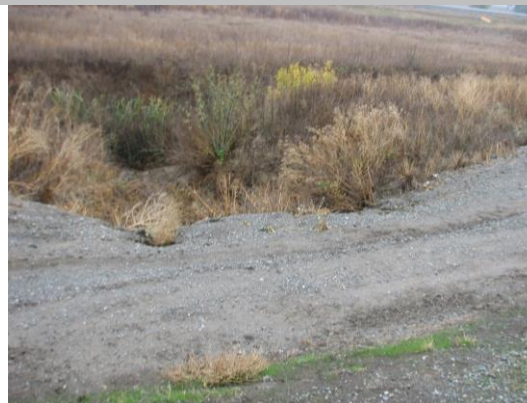
Photo 1 of 1 : SP_2015_ST0012_296_9_20150401_00004.jpg

LM Start	2.97	Rating **	M	Issue No.	9
LM End	2.97	Issue Type +	Ma	Location *	WS
Category	Earthen Levee			GPS Latitude/Longitude	
				Start	End
Item	Erosion / Bank Caving			38.589686 °	38.589686 °
				-121.705041 °	-121.705041 °
DWR ID	DWR_ST0012_02_f_2014_9				
Action/Comments					
Note and monitor erosion site.

Erosion on toe road. Fall 2014.

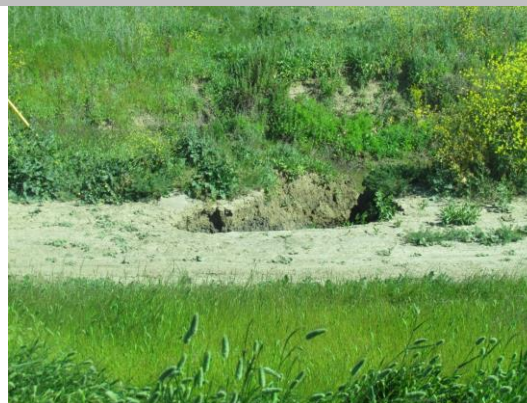
Photo 1 of 1 : SP_2015_ST0012_296_12_20150421_00010.jpg

LM Start	4.12	Rating **	M	Issue No.	12
LM End	4.12	Issue Type +	Ma	Location *	WS
Category	Earthen Levee			GPS Latitude/Longitude	
				Start	End
Item	Erosion / Bank Caving			38.589548 °	38.589548 °
				-121.683679 °	-121.683679 °
DWR ID	DWR_ST0012_02_s_2015_12				
Action/Comments					
Note and monitor erosion site.

View of the erosion on the edge of the channel on the water ward side of the levee. Spring 2015.

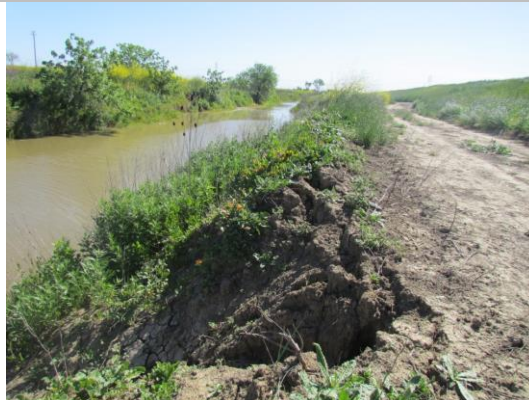
Photo 1 of 1 : SP_2015_ST0012_296_14_20150421_00013.jpg

LM Start	5.02	Rating **	M	Issue No.	14
LM End	5.02	Issue Type +	Ma	Location *	WS
Category	Earthen Levee			GPS Latitude/Longitude	
				Start	End
Item	Erosion / Bank Caving			38.589572 °	38.589572 °
				-121.667144 °	-121.667144 °
DWR ID	DWR_ST0012_02_s_2015_14				
Action/Comments					
Note and monitor erosion site.

View of the erosion on the edge of the channel on the water ward side of the levee looking downstream.

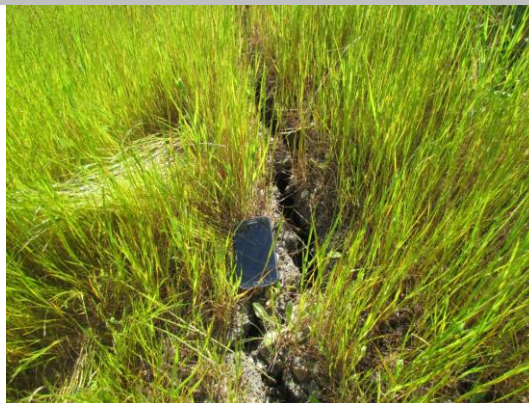
Photo 1 of 2 : SP_2015_ST0012_296_13_20150421_00011.jpg

LM Start	5.02	Rating **	M	Issue No.	13
LM End	5.02	Issue Type +	Ma	Location *	WS
Category	Earthen Levee			GPS Latitude/Longitude	
				Start	End
Item	Cracking			38.589572 °	38.589572 °
				-121.667143 °	-121.667143 °
DWR ID	DWR_ST0012_02_s _ 2015_13				
Action/Comments					
Monitor and have inspected by geotechnical engineer.

View of the crack on the water ward side of the levee. Spring 2015.

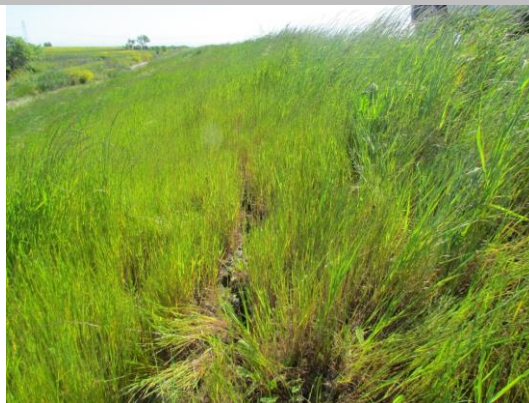
Photo 2 of 2 : SP_2015_ST0012_296_13_20150421_00012.jpg

LM Start	5.02	Rating **	M	Issue No.	13 (cont)
LM End	5.02	Issue Type +	Ma	Location *	WS

View of the perspective of the cracking on the water ward side of the levee looking downstream. Spring 2015.

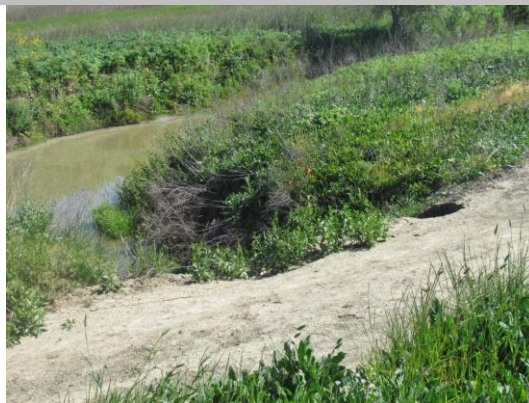
Photo 1 of 1 : SP_2015_ST0012_296_15_20150421_00014.jpg

LM Start	5.05	Rating **	M	Issue No.	15
LM End	5.05	Issue Type +	Ma	Location *	WS
Category	Earthen Levee			GPS Latitude/Longitude	
				Start	End
Item	Erosion / Bank Caving			38.589570 °	38.589570 °
				-121.666588 °	-121.666588 °
DWR ID	DWR_ST0012_02_s _ 2015_15				
Action/Comments					
Note and monitor erosion site.

View of the erosion on the edge of the channel on the water ward side of the levee. Spring 2015.

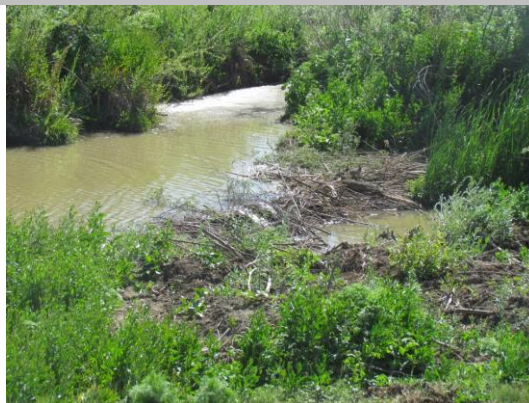
Photo 1 of 1 : SP_2015_ST0012_296_16_20150421_00015.jpg

LM Start	6.15	Rating **	A/W	Issue No.	16
LM End	6.15	Issue Type +	Ma	Location *	WS
Category	Earthen Levee			GPS Latitude/Longitude	
				Start	End
Item	Animal Control			38.587968 °	38.587968 °
				-121.647392 °	-121.647392 °
DWR ID	DWR_ST0012_02_s _ 2015_16				
Action/Comments					
No rodents visible, but rodent burrows visible; need to backfill and compact or grout burrows. Inspector Comments: There seems to be a beaver dam blocking the channel.

View of a beaver dam in the channel. Spring 2015.
